BUREAU OF SHIPS GROUP
TECHNICAL INSPECTION REPORT

⑥ OPERATION CROSSROADS.
U.S.S HUGHES (DD410).
TEST BAKER.

VOLUME II [u] ⑧

USS HUGHES (DD410)

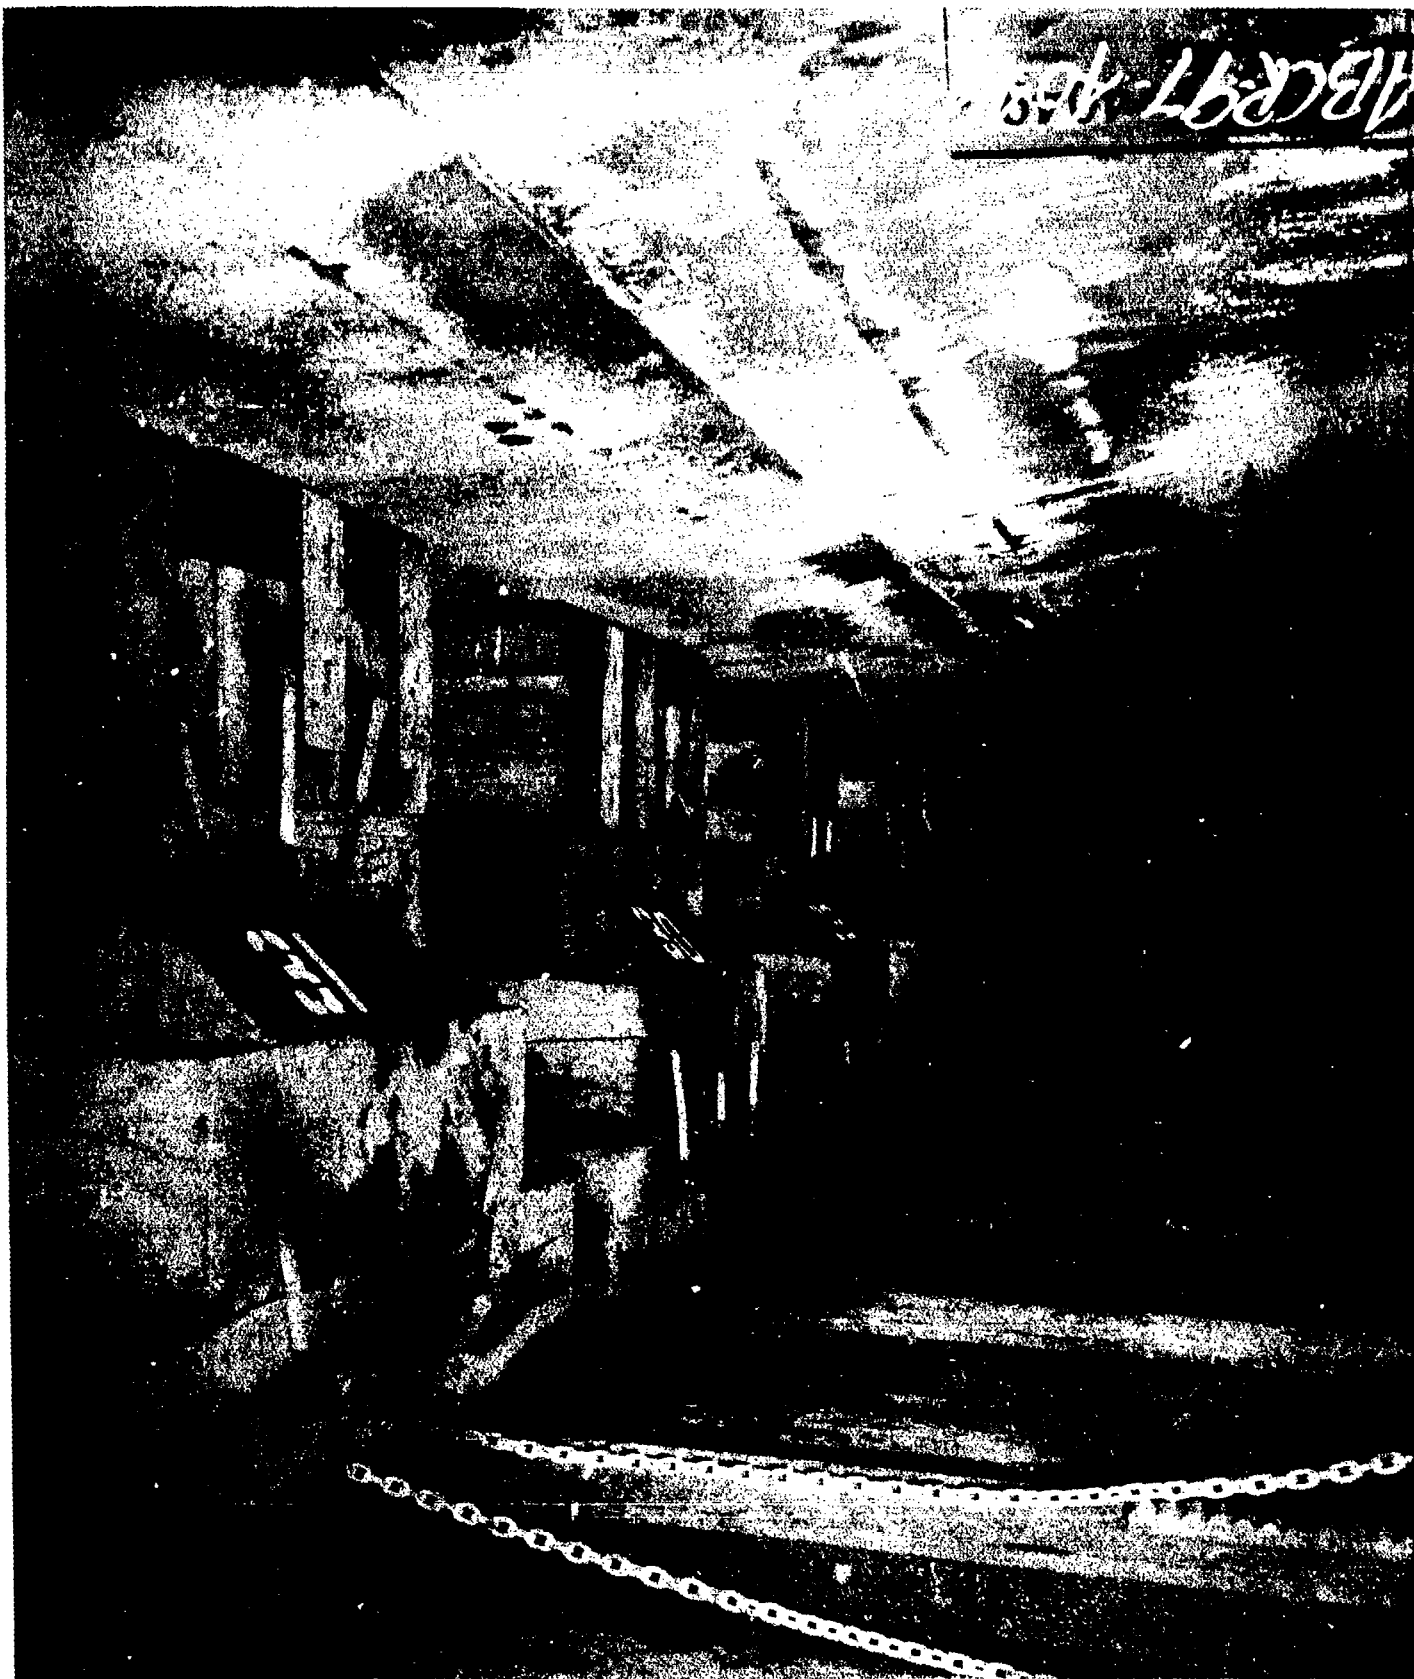
AB-CR-97-4049-10. Starboard bottom shell, looking forward from Frame 90 along garboard strake, note white coral sand imbedded in paint during grounding.

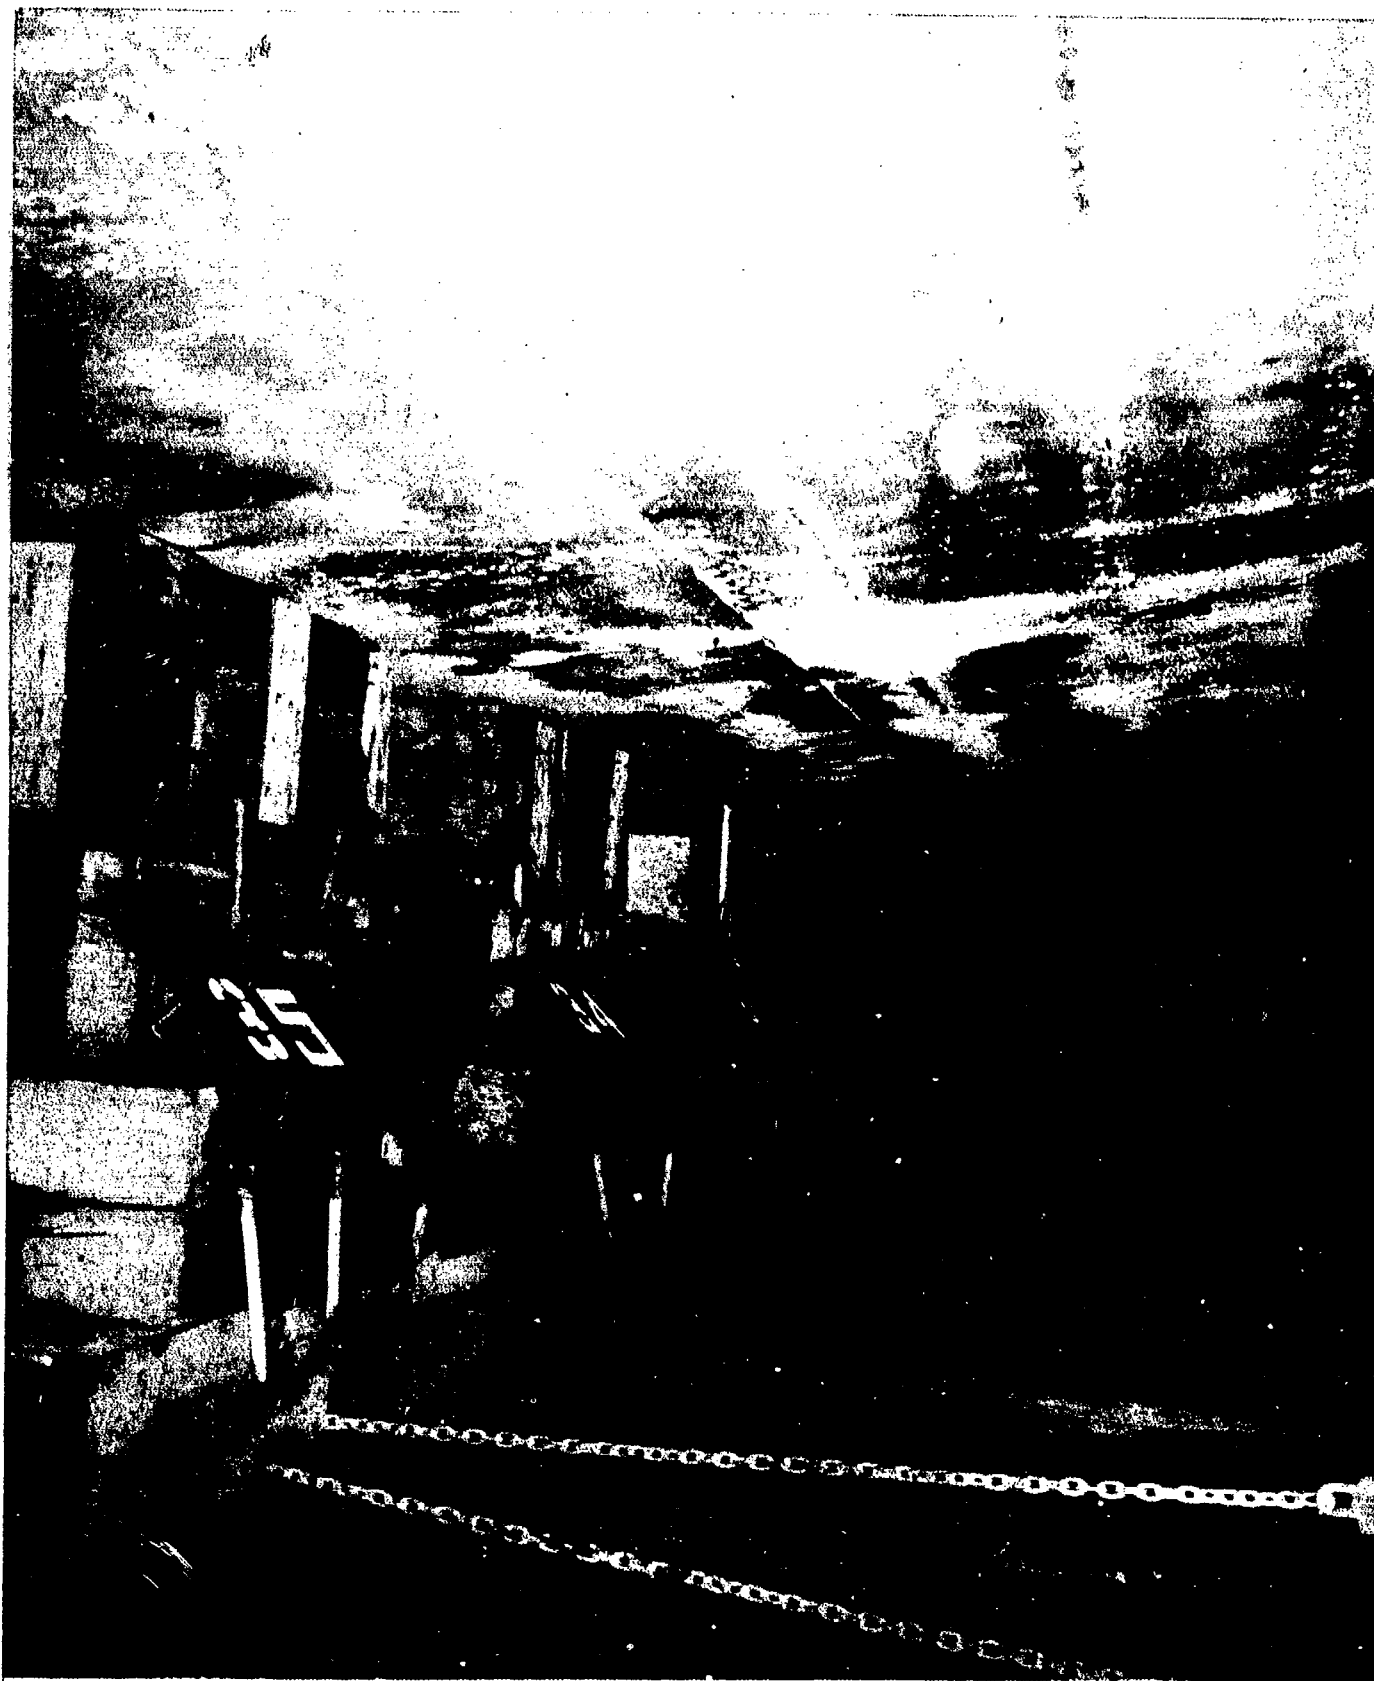
AB-CR-97-4049-8. Starboard bottom shell, looking forward, frames 110-115.

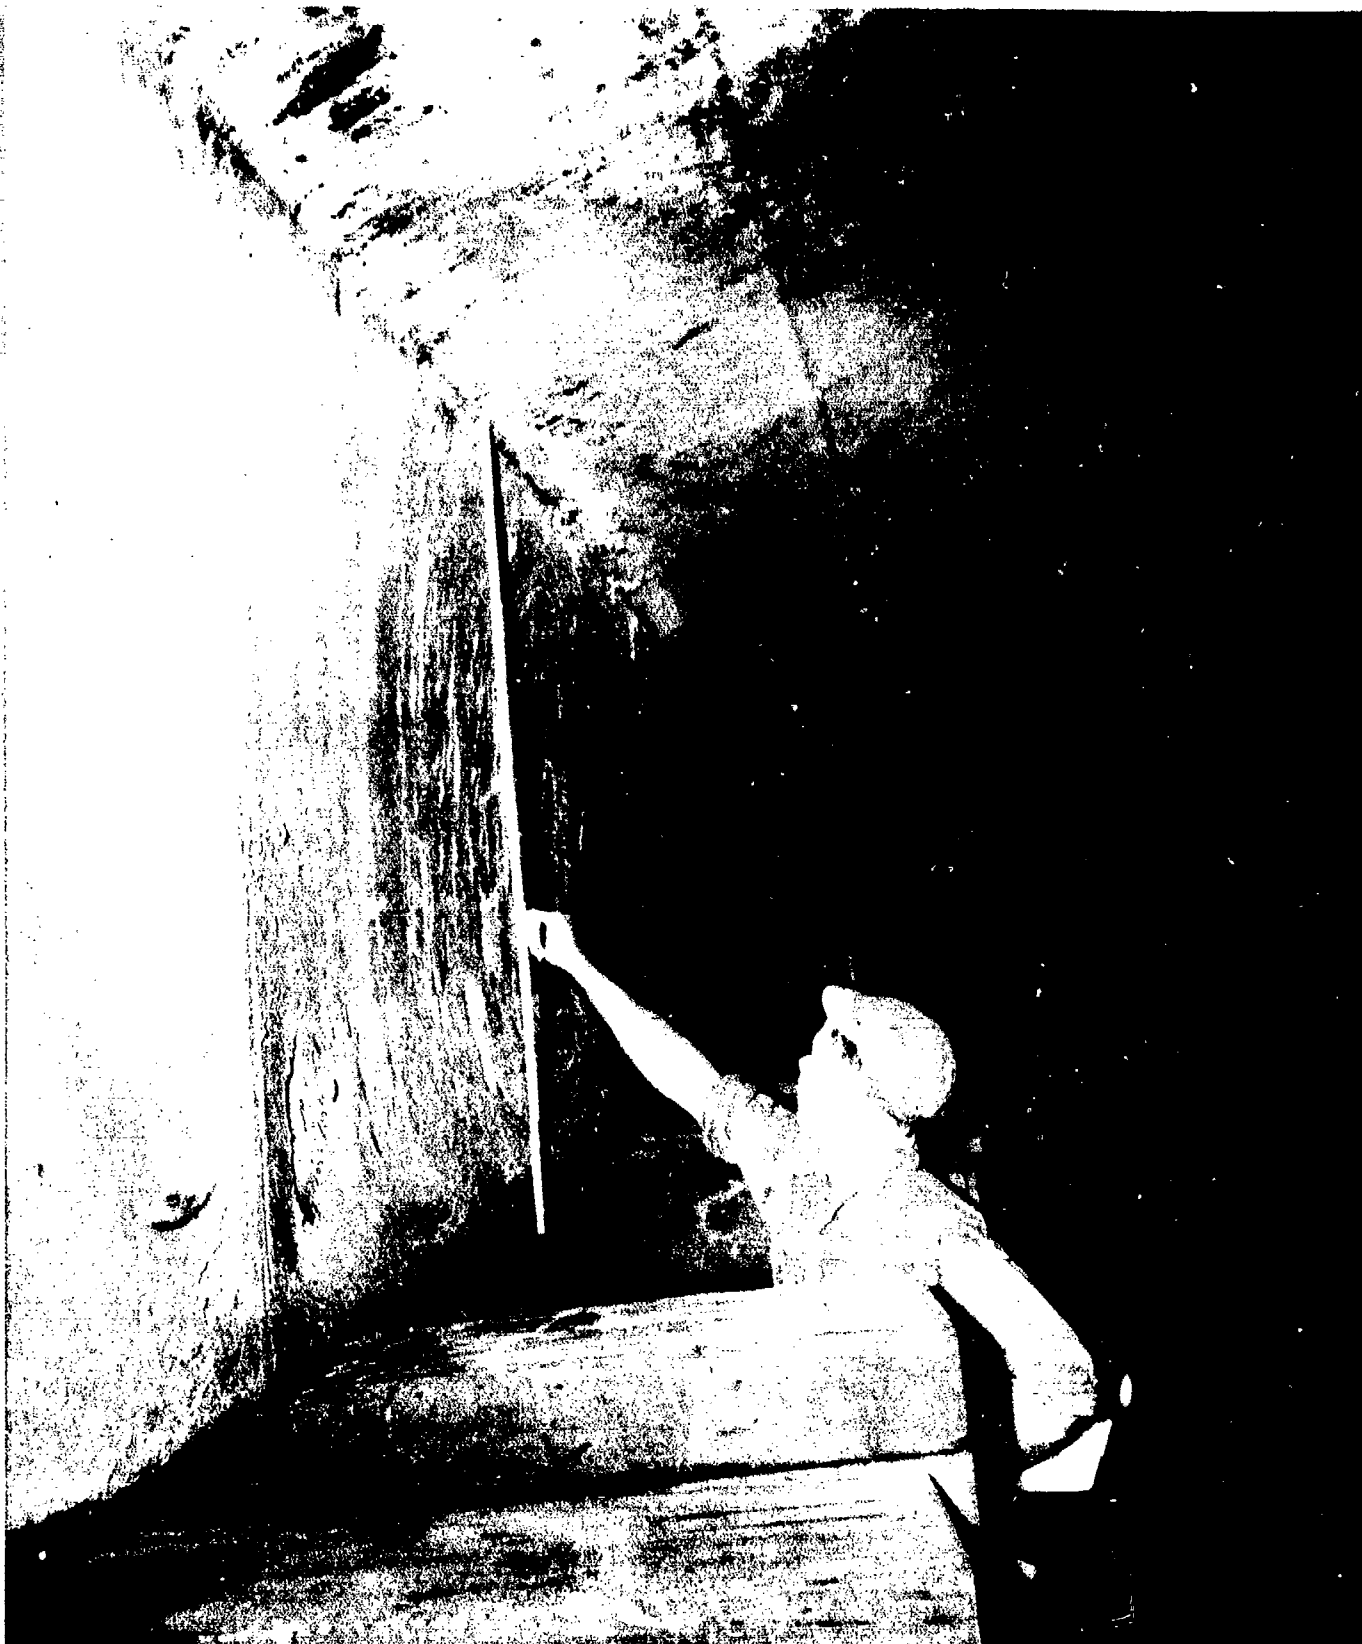
AB-CR-234-4060-9. Starboard side of skeg looking forward (Note dishing).

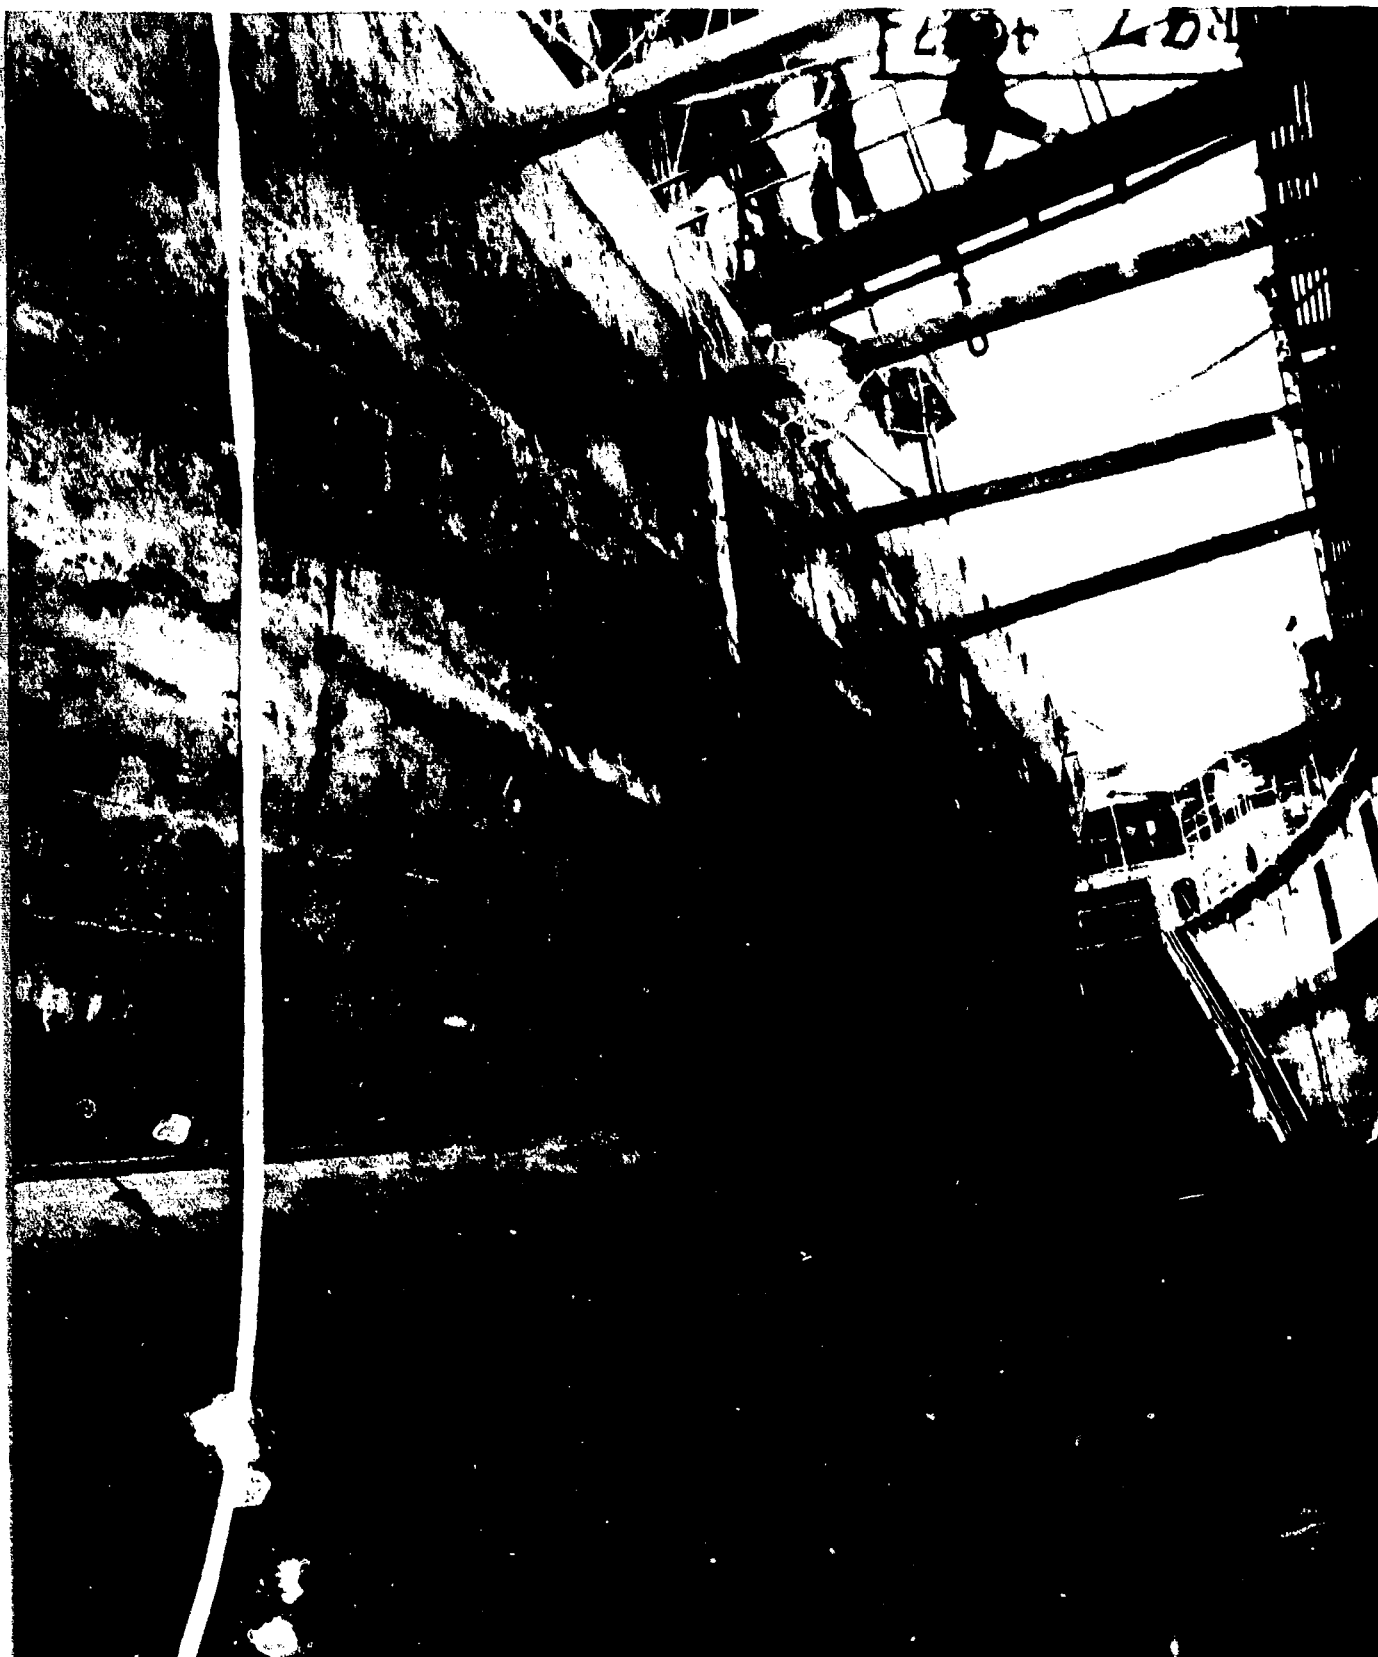
AB-CR-97-4057-9. Starboard shell looking forward, frames 100-50.

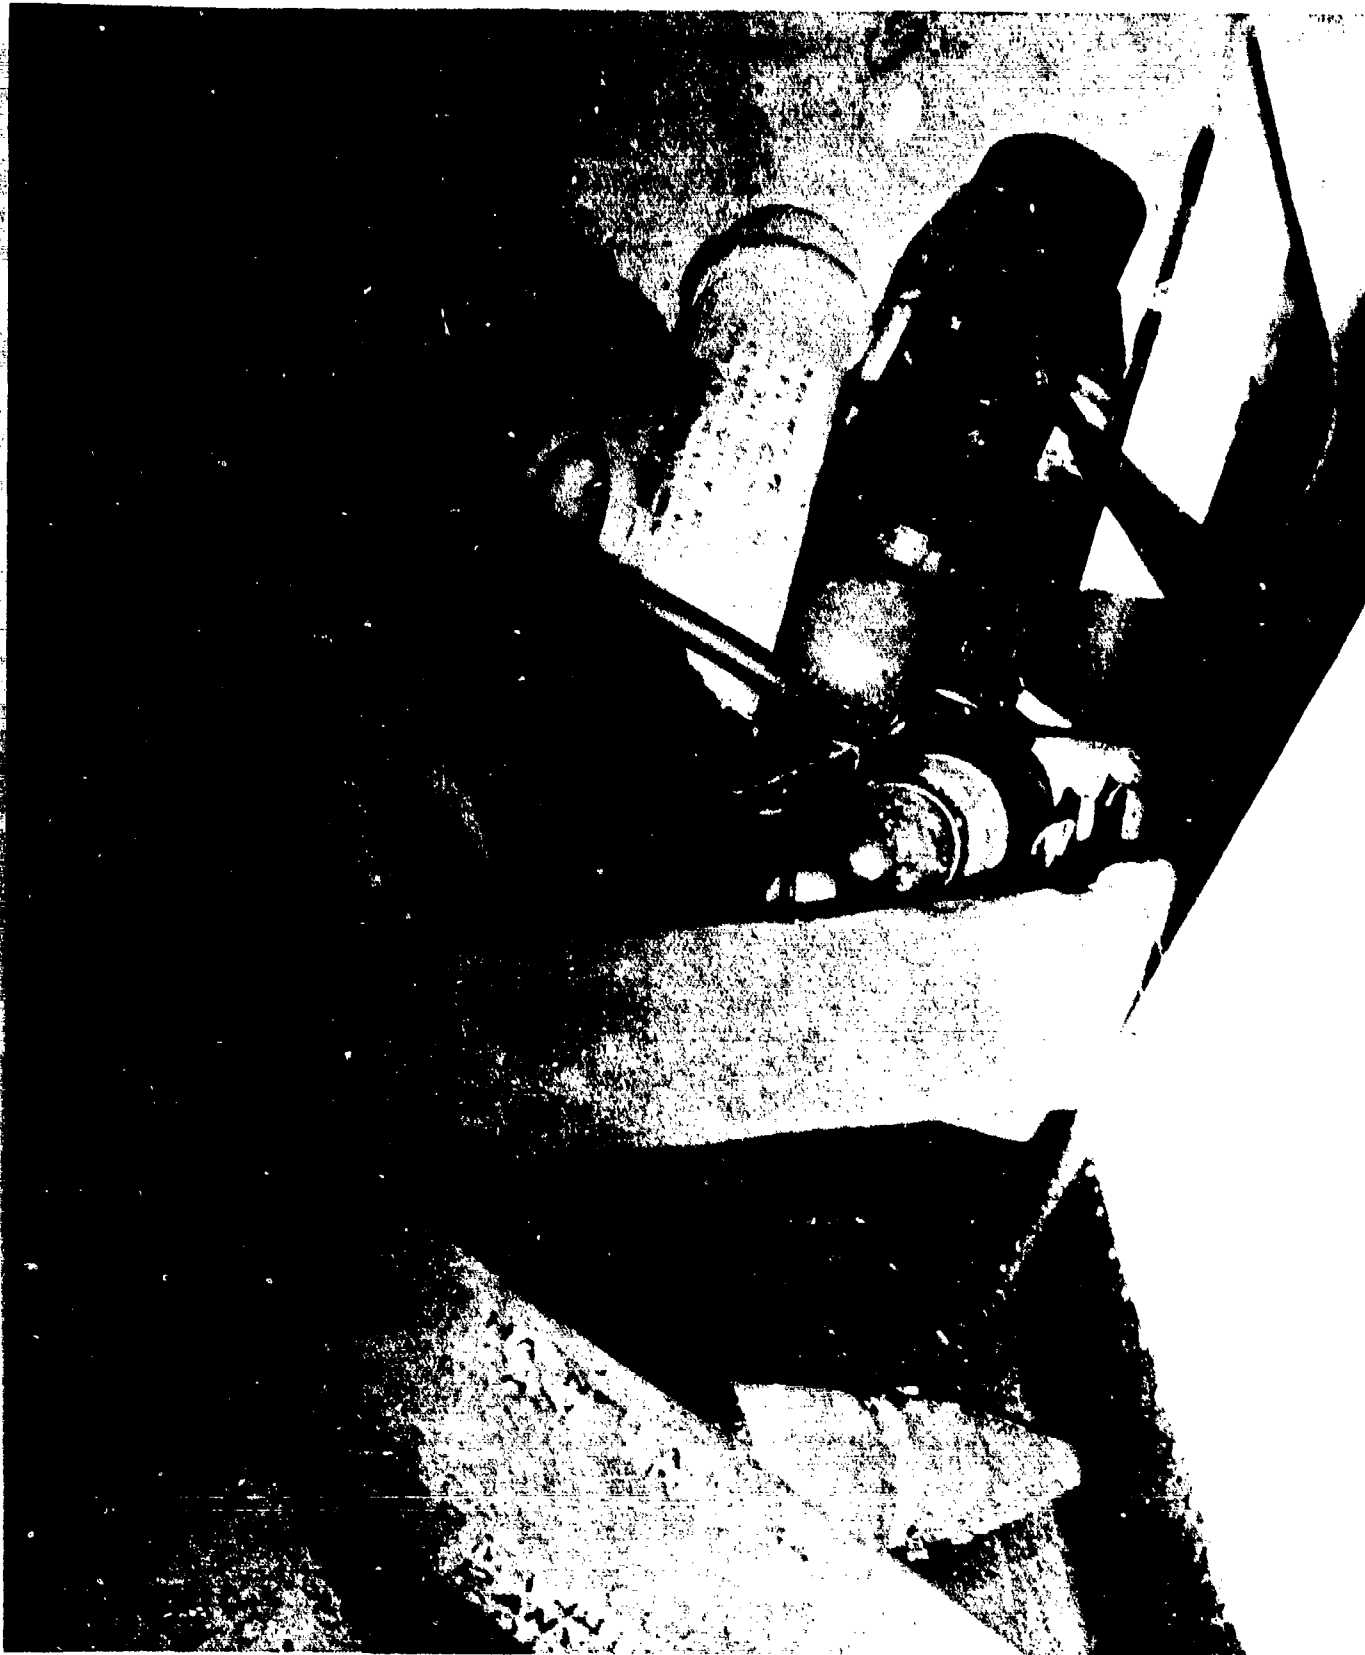
AB-CR-100-4211-2. Displacement of 5 inch ammunition thrown into head, port side from handling room A-104-IMT on main deck, frames 25-33.

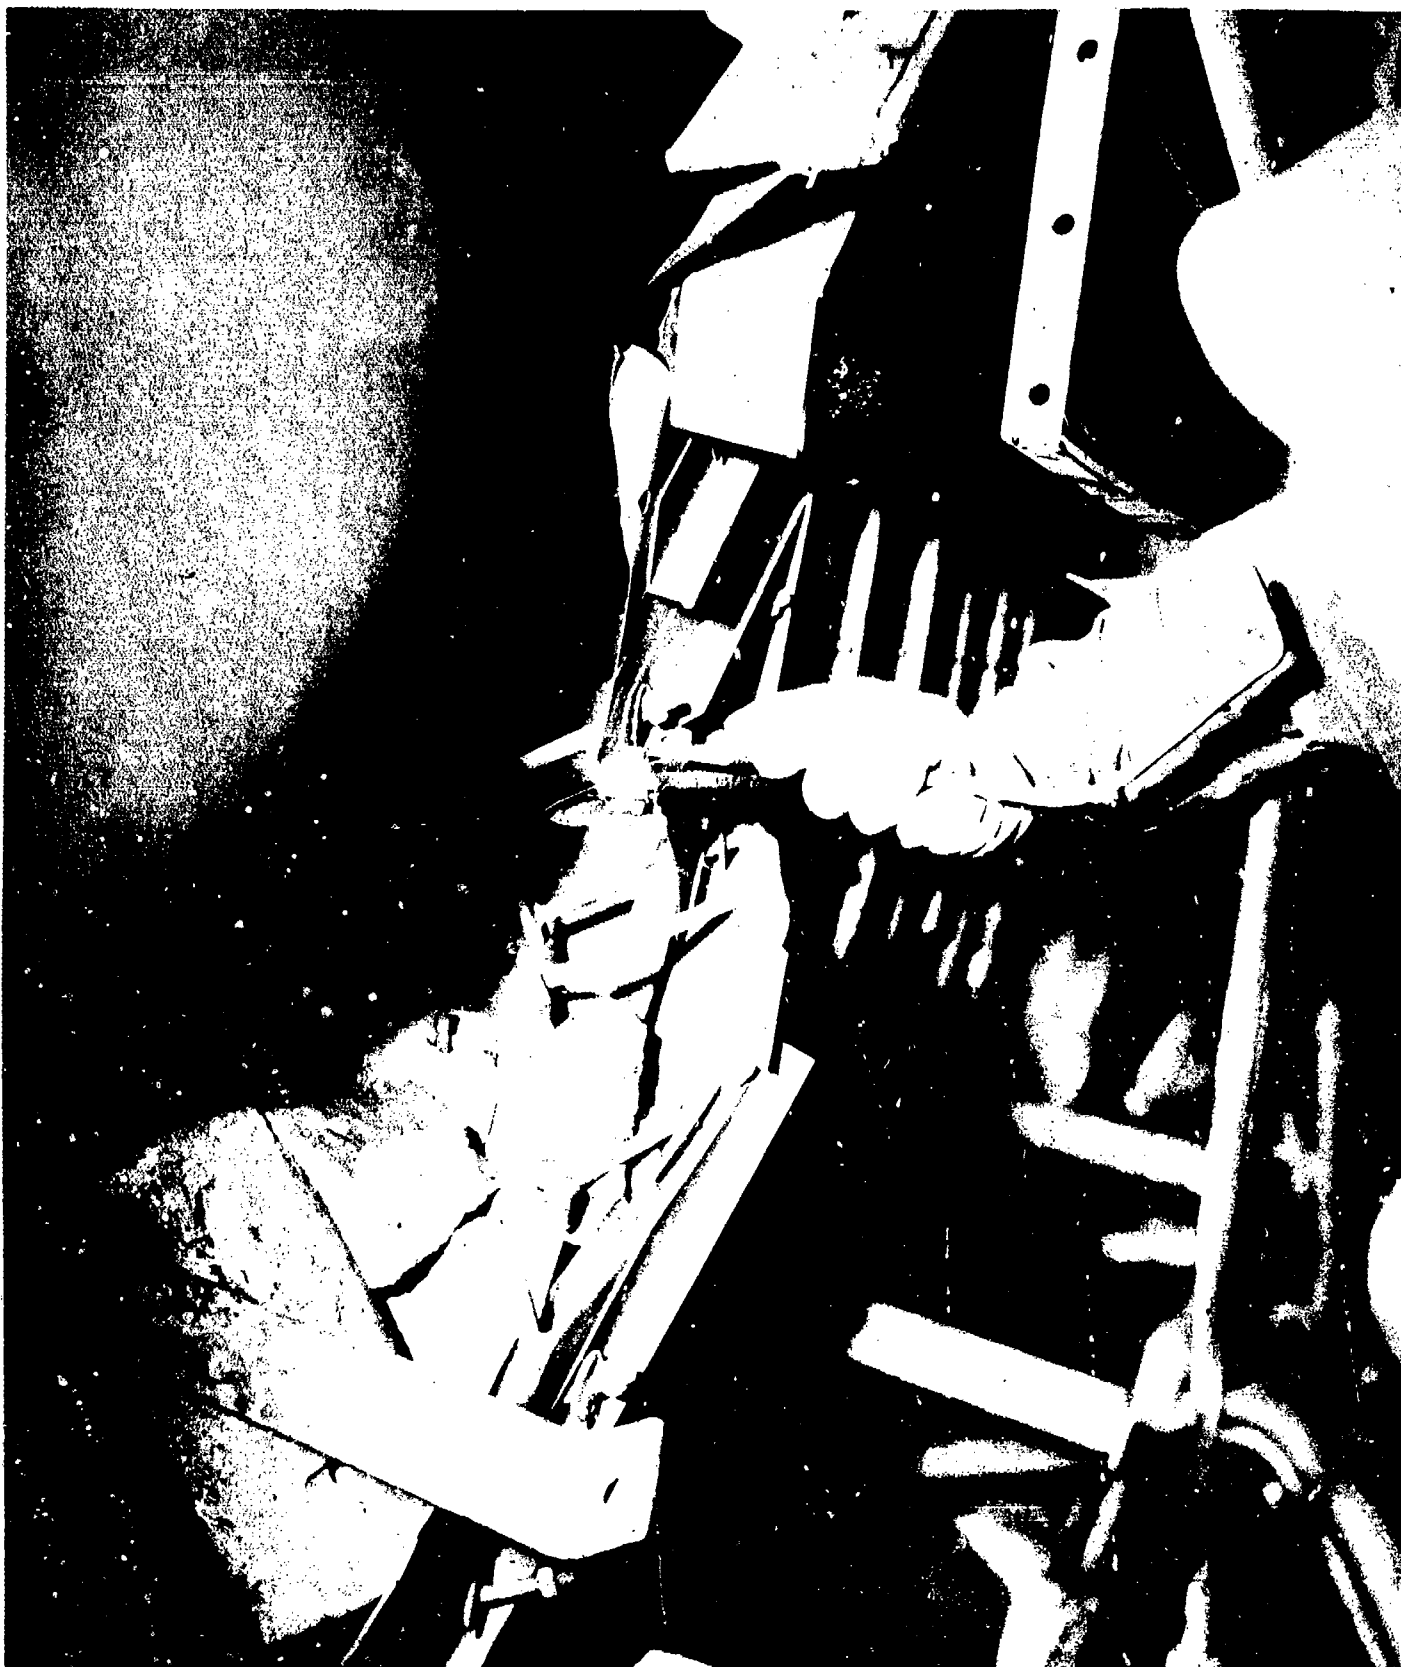
AB-CR-76-2078-6. No. 2 boiler, rear casing.

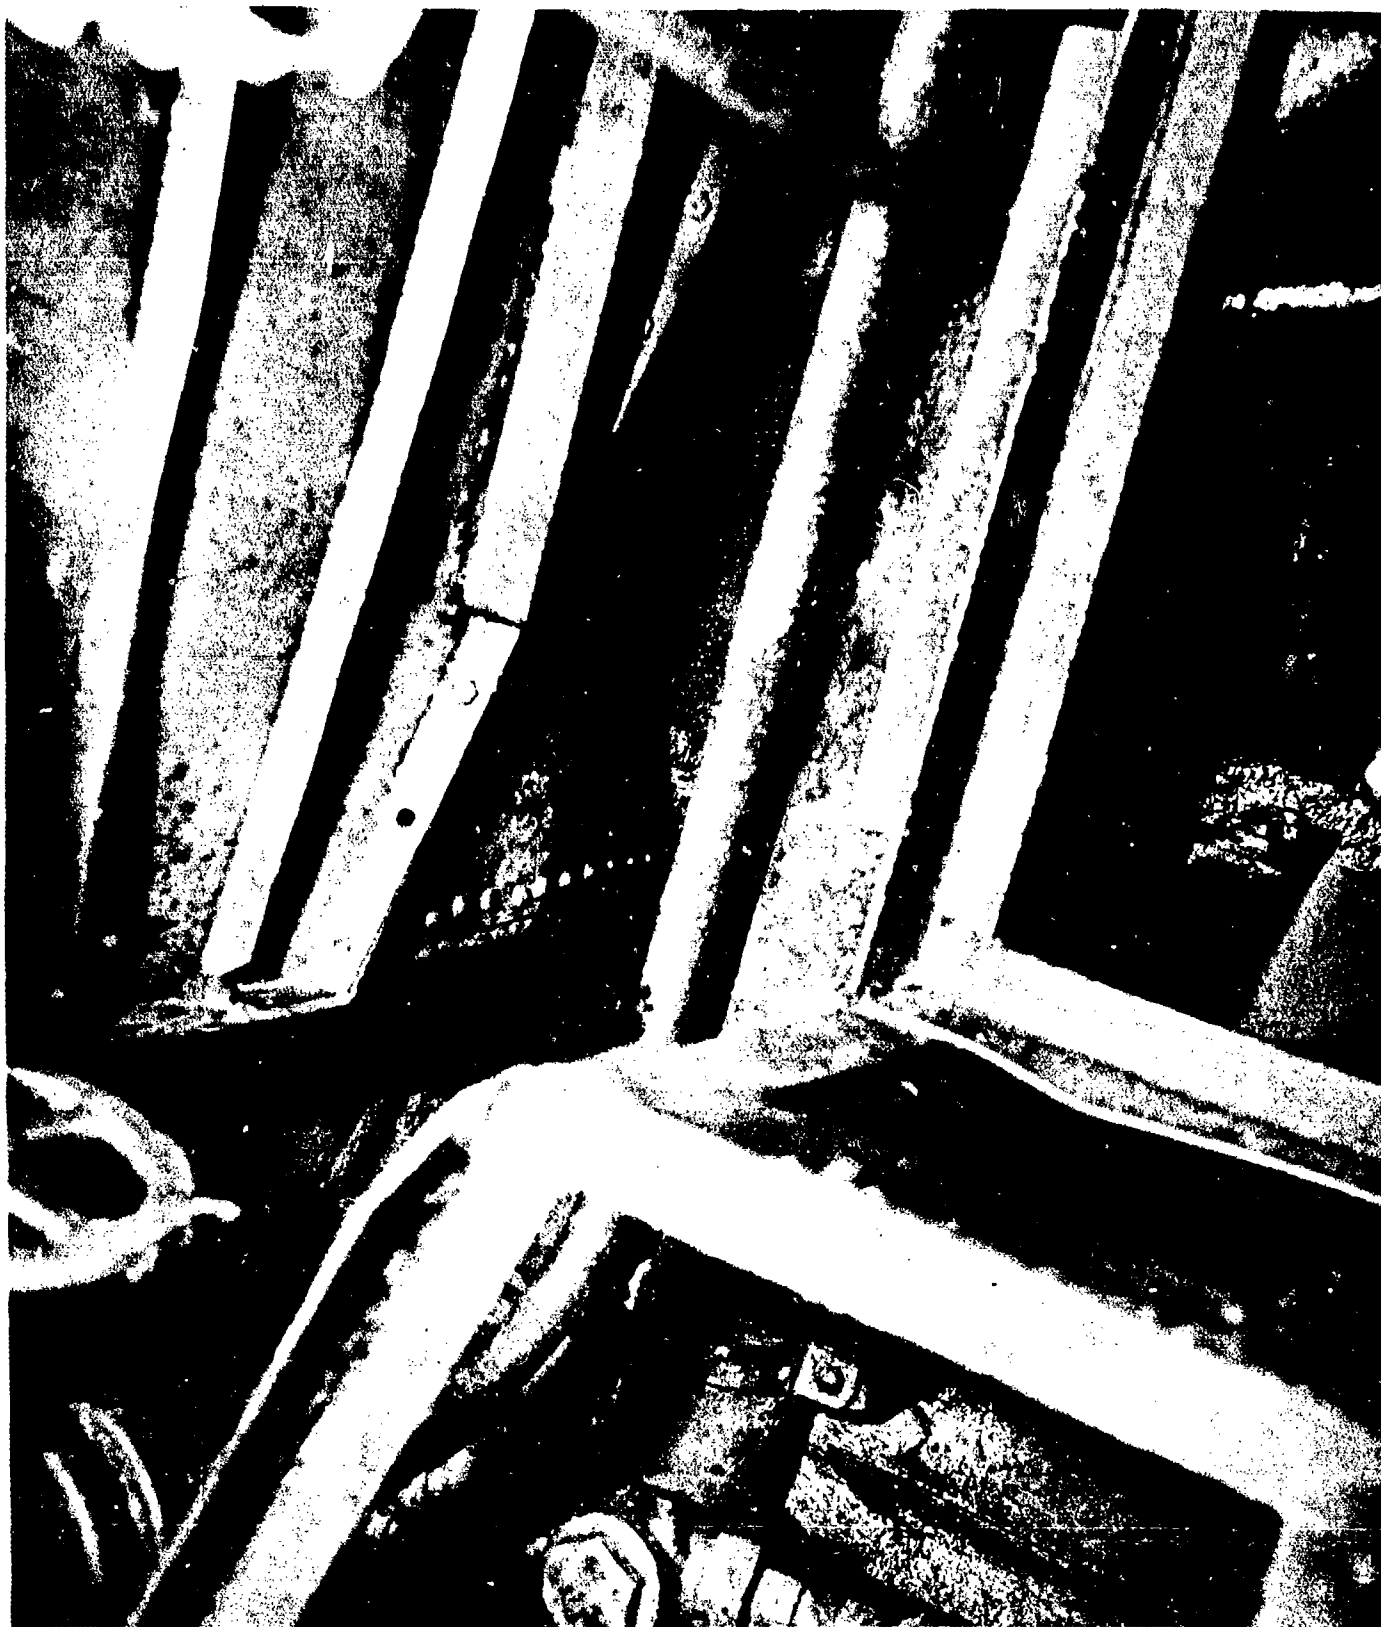
AB-CR-76-2076-10. No. 2 boiler, lower front casing, starboard side.

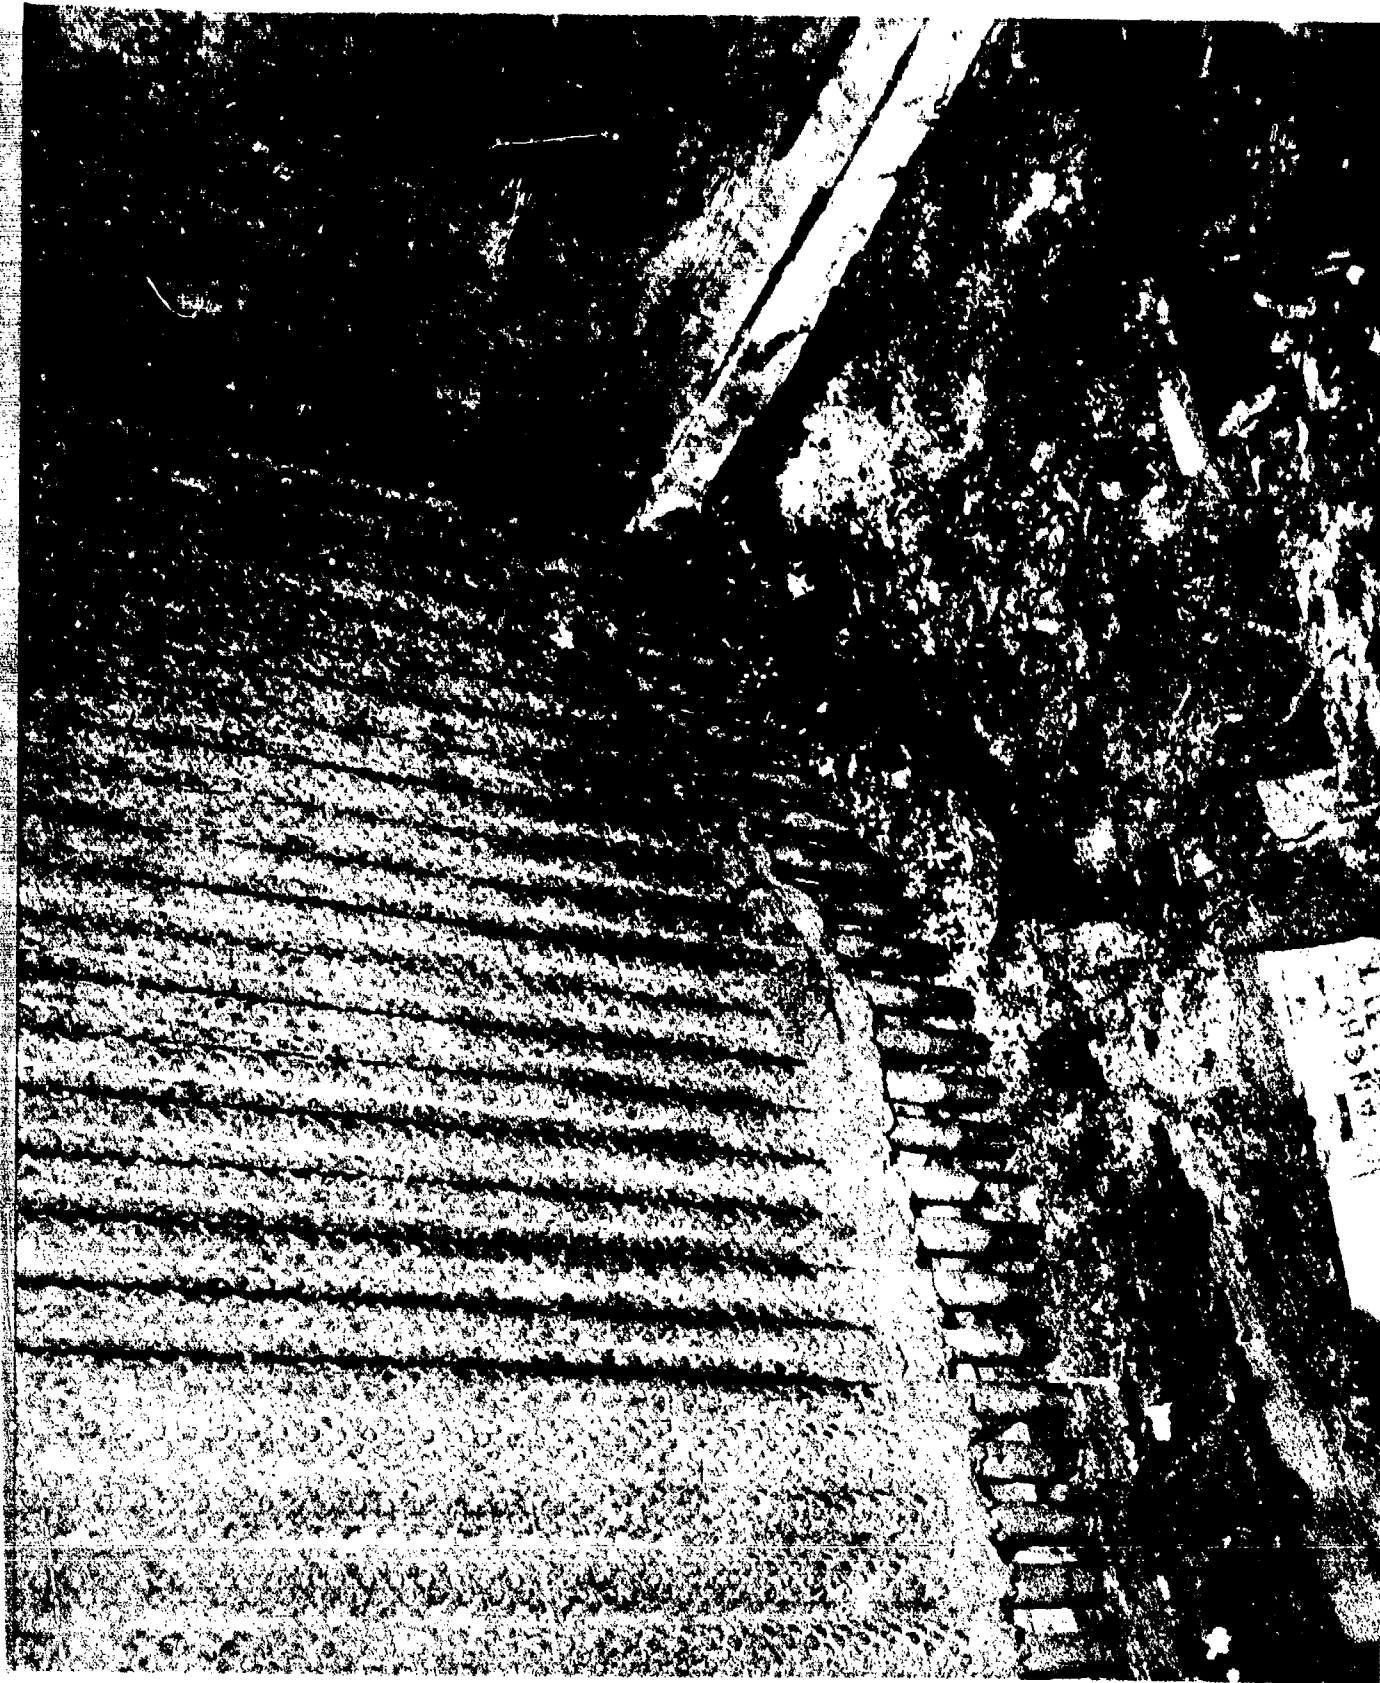
AB-CR-76-2076-3. No. 2 boiler, saturated side furnace, floor at rear inboard corner.

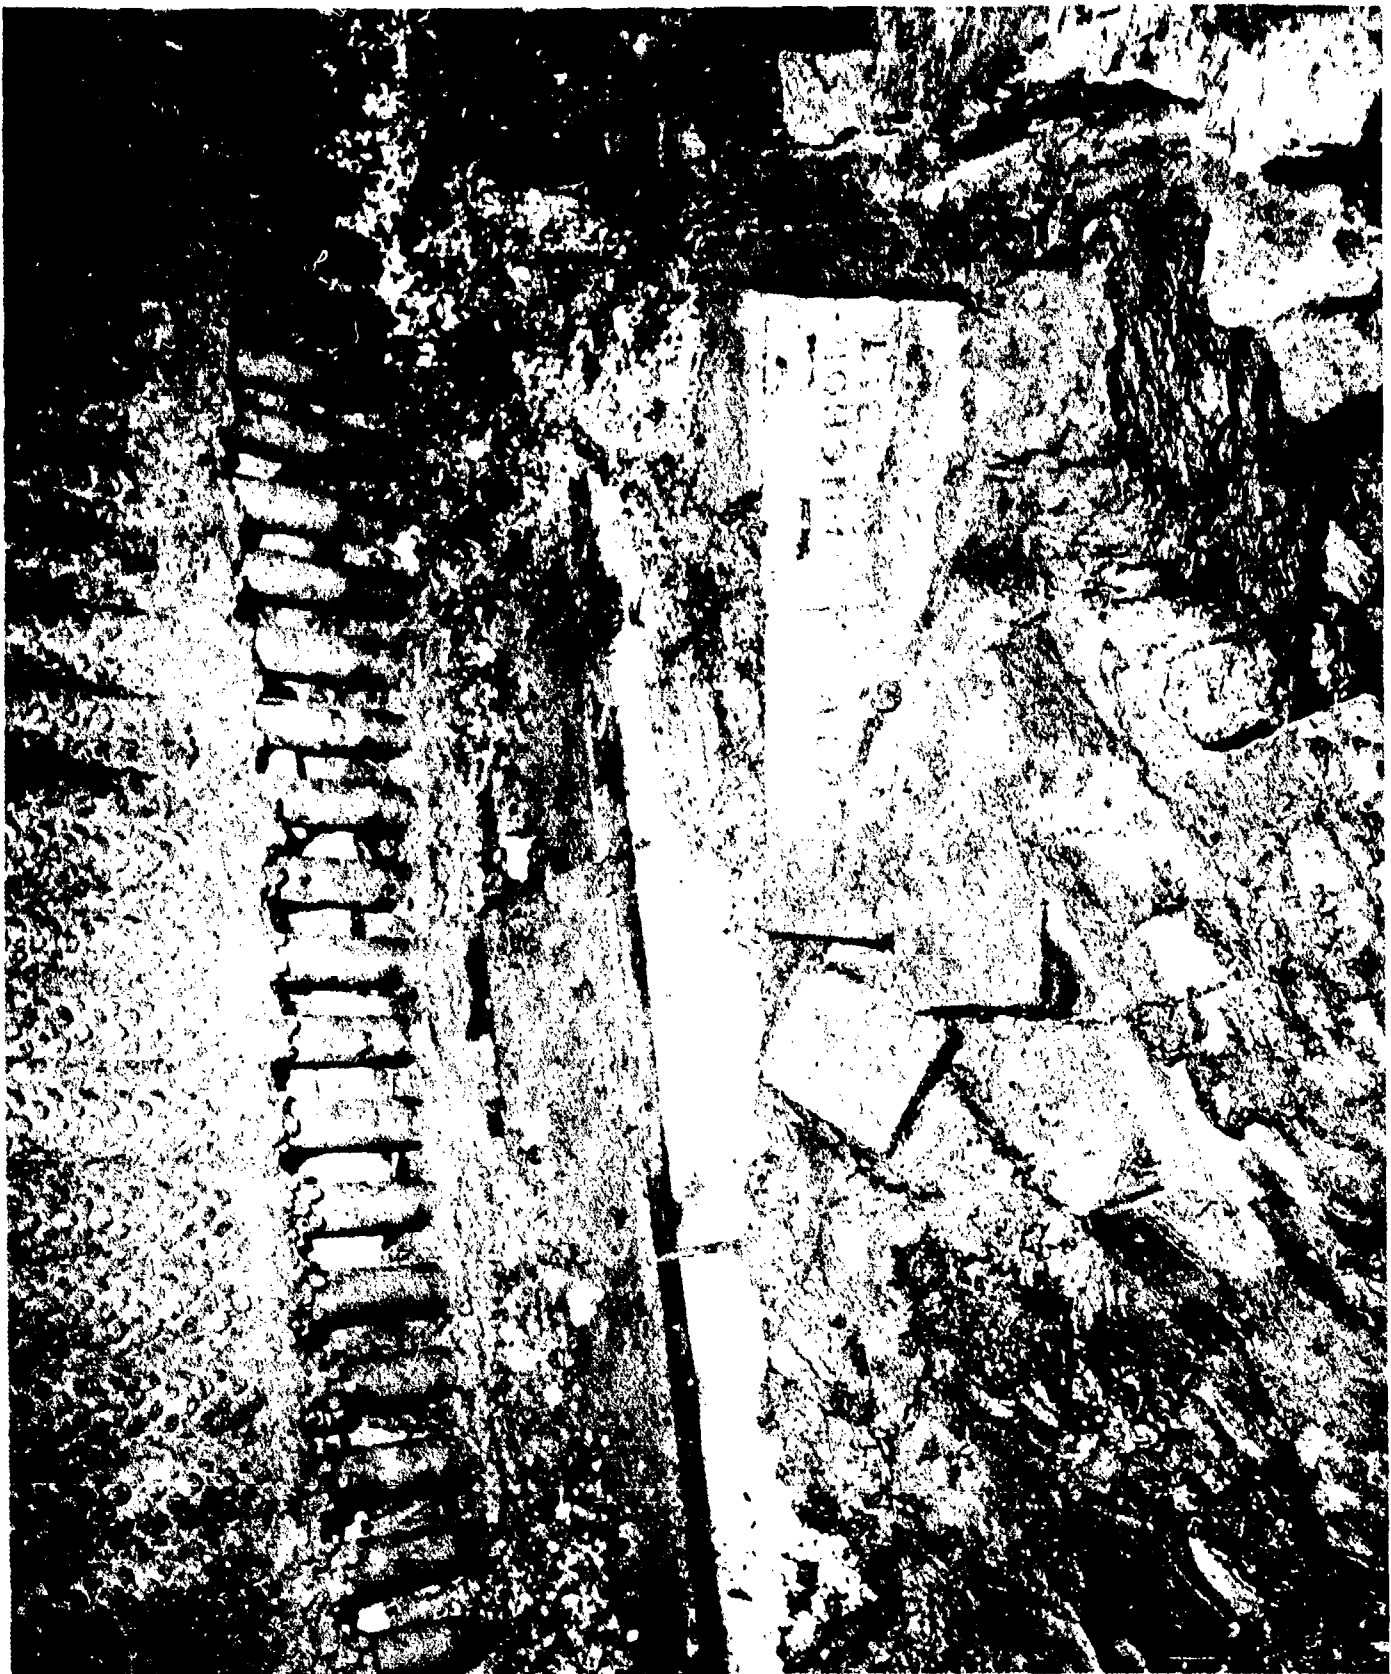
AB-CR-76-2076-4. No. 2 boiler, saturated side furnace, brickpan at division wall.

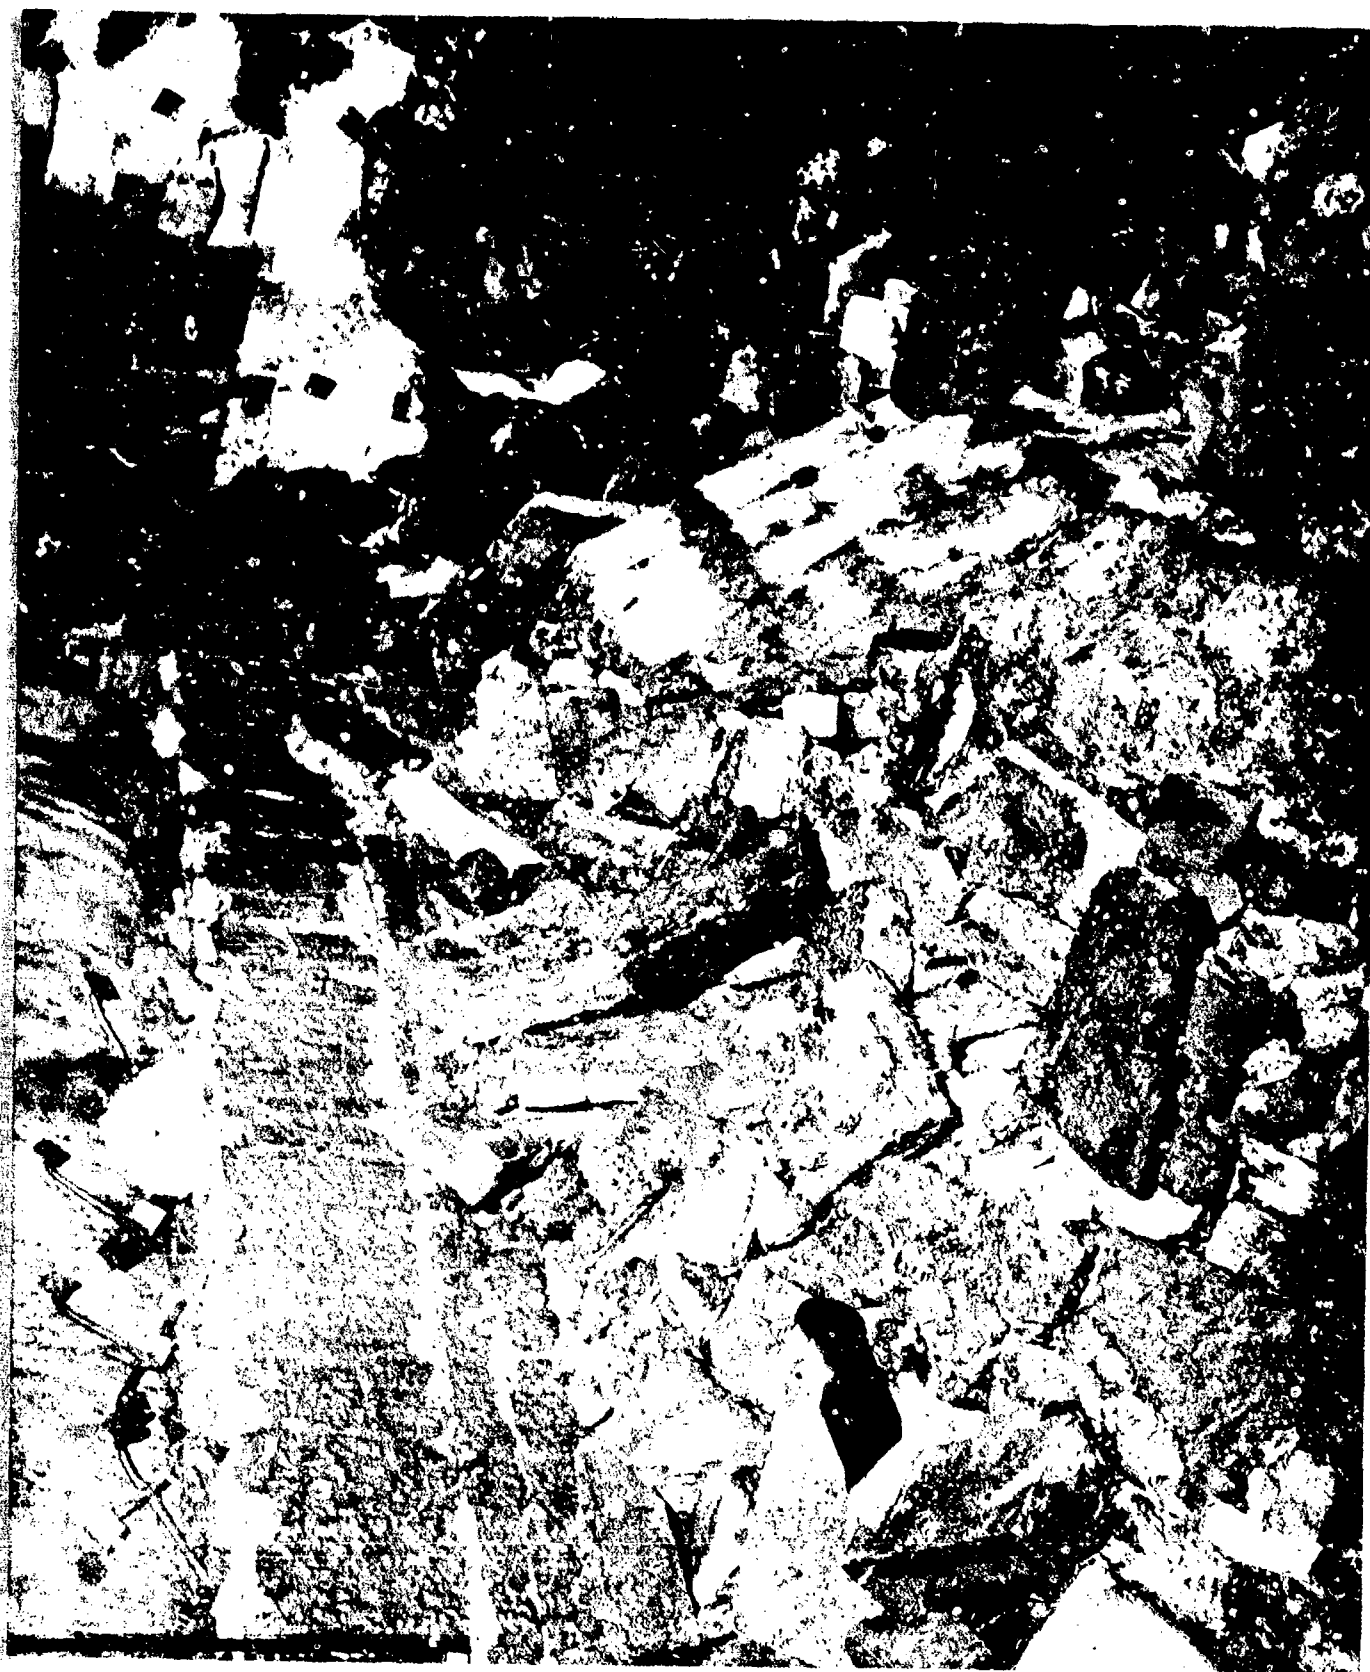
AB-CR-76-2076-5. No. 2 boiler, saturated side furnace, displaced brick piled on outboard side.
